Harding Lawson Associates

June 24, 1993

**Sewer - Storm Drain Interconnection
Parcel A/B Boundary near Building 101 & 110
Hunters Point Annex
San Francisco, California**

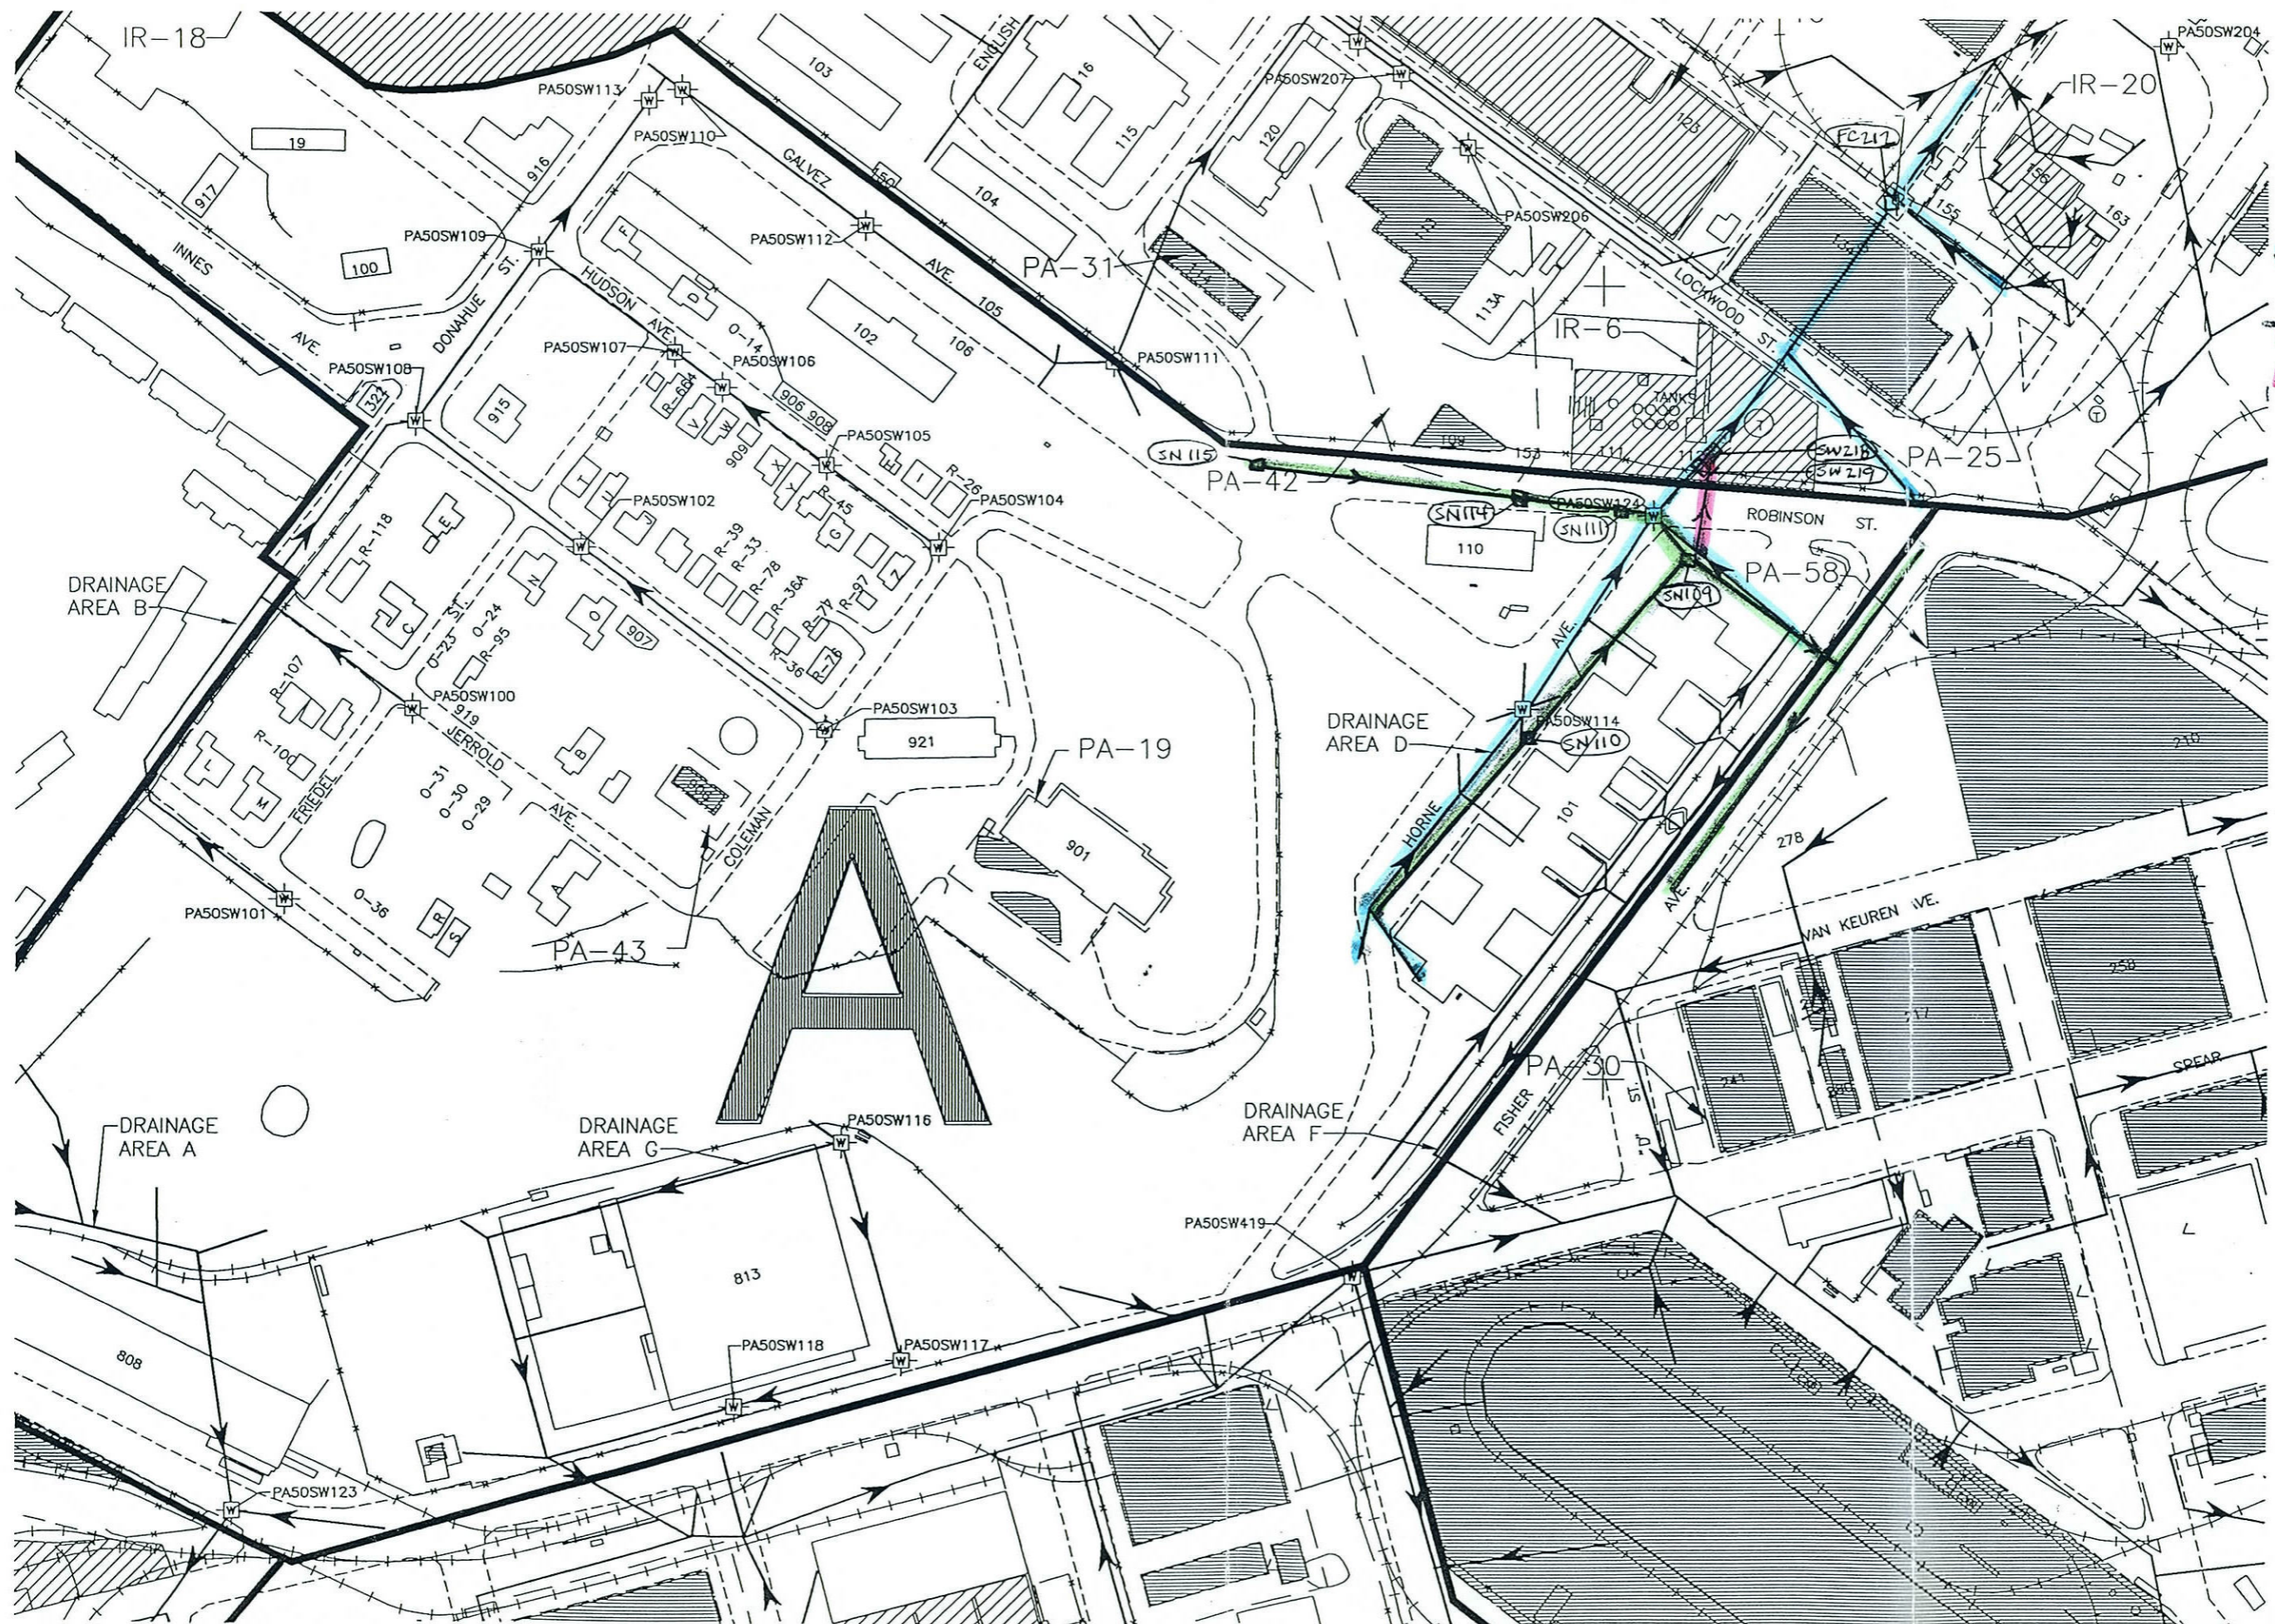
CONTROL DIAGRAM

These observations indicate sewage from the sanitary sewer servicing Buildings 101 and/or 110 (green on attached plate) enters the storm drain system (blue) at PA50SW218. The Navy Control Diagram (1950) shows two combined storm and sewer lines extending downslope from Robinson Street to the Tank Farm. The easternmost of the two lines (colored pink) approximates the orientation of the sewer line entering PA50SW218.

Based on this preliminary data, it appears that at least one of the pre-1950 combined sewer-storm lines is still active and interconnects sewage from Parcel A with the storm drain system in Parcel B.

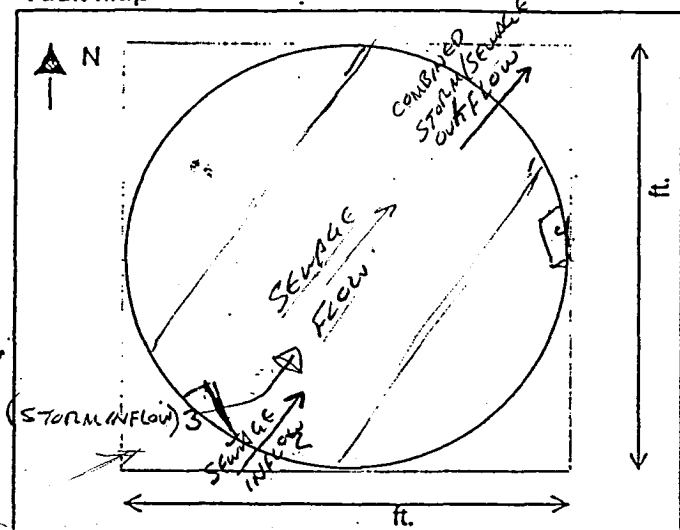
Vault Map

PA50SW218 - Strong sewage odor, sewage appears to flow into this manhole via a 27- to 30-inch-diameter pipe. The sewage inflow pipe deviates slightly east from the storm drain inlet. Combined storm/sewage flows move toward flood control structure FC212.

Invert depth (TD)	: 5	Sediment depth:	unknown
Depth to water below rim	: 4.8	Sediment type:	Bricks, Pipe fragments, sand
Depth of water	: 0.2	Flow Rate (fast, slow, stagnant):	
OVA/Gastech readings:	4 ppm	Photo # / direction of view:	
Evidence of contamination:	strong sanitary sewer odor, water is grayish in color		
Vault conditions/other observations:			
Sample number(s)/matrix:
